Transite Pipe Characterization  
Pipe Survey  
5-14-09

B. Wright

5-14-09

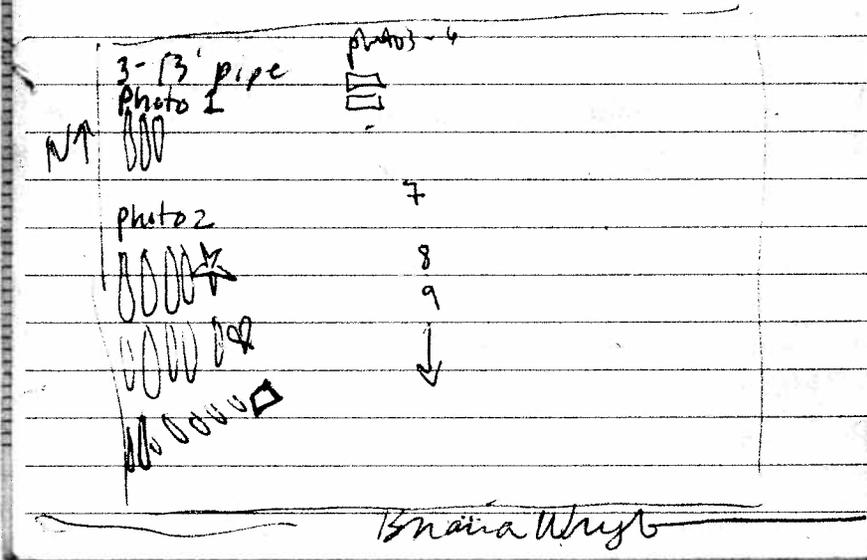
Points on map  $\otimes$  in HA-1 are  
 four corners of pipe areas  
 HA-1
